Post-Fire Structural Health Assessment of Reinforced Concrete Structures

Amandeep ¹, Monu Kumar ², Harish Chawla ³ Department of Civil Engineering
BRCM College of Engineering & Technology, Bahal, India

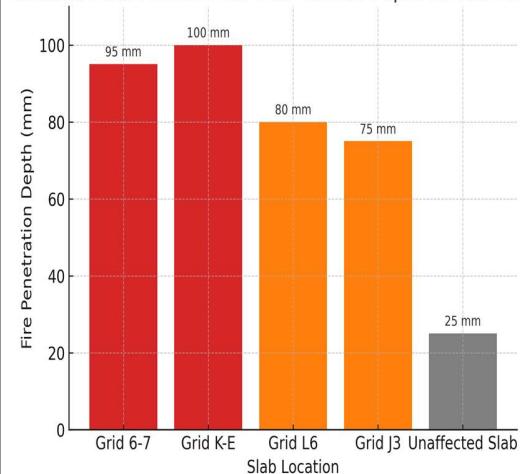
Thermal Scan Results: Fire Penetration Depth vs Slab Location

Thermographic scans were used to assess fire penetration depth and delamination in slabs. Variations in surface temperature highlighted voids and cracks. Fire penetration of 75–100 mm was observed in soffits of fire-exposed slabs, indicating significant loss of cover and

compressive strength in those regions.

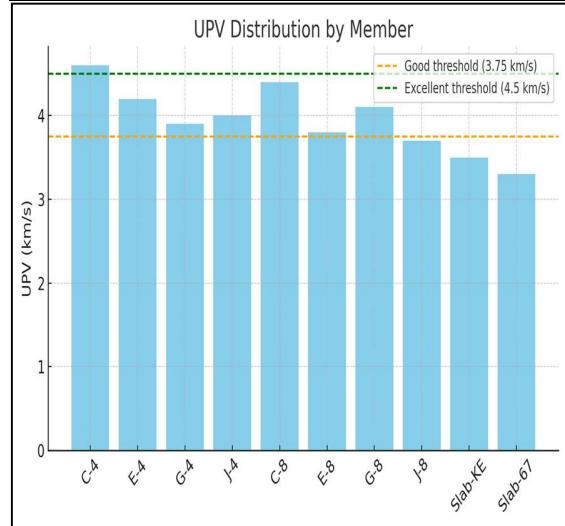
Fig. 4.1. UPV distribution by Structural frame members

Pulse velocity values ranged from 3.2 to 4.0 km/s. Over 70% of members fell within the "Good to Excellent" classification per IS 13311. However, values below 3.5 km/s were observed in fire-exposed slabs and columns, indicating microcracking and internal voids.

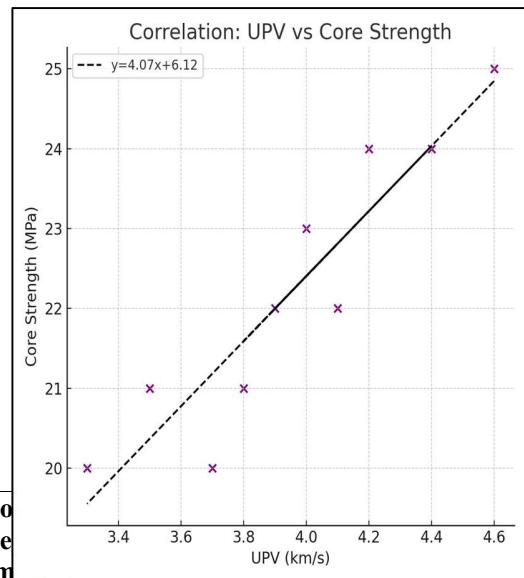
Fig. 4.2 Correlation between Rebound Hammer and Core Strength

Scatter plots demonstrated good correlation: UPV vs Core ($R^2 \approx 0.78$) and Rebound vs Core ($R^2 \approx 0.70$). This confirms the reliability of NDT for rapid post-fire evaluation when calibrated with core samples.

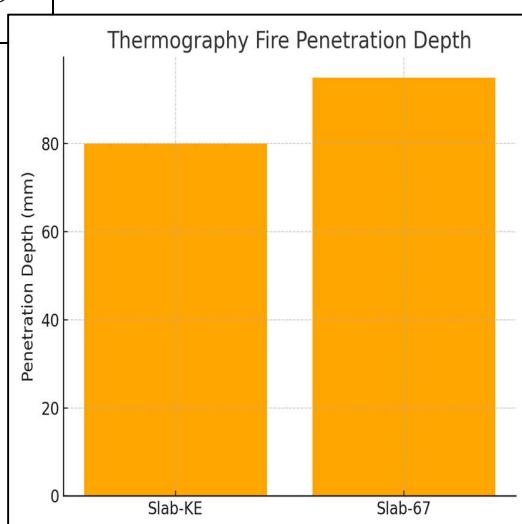
Fig. 4.3 Thermography Fire Penetration Depth in Slabs

Infrared thermography revealed fire penetration depths of 75–100 mm in slab soffits, consistent with visible spalling zones. This indicates that beyond 100 mm, material integrity remains unaffected.

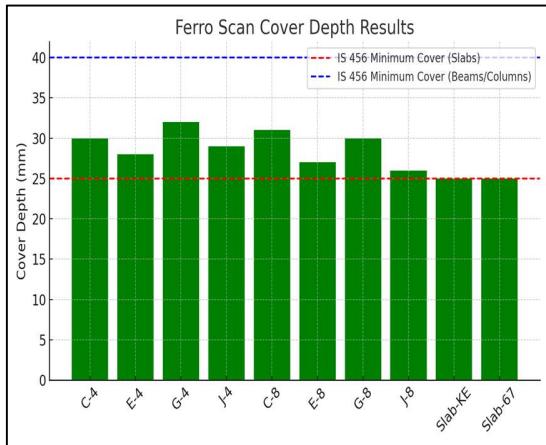
Fig. 4.4 Ferro Scan Cover Depth Results vs IS 456 Requirements

Cover depths measured 25–35 mm, meeting slab requirements but falling short of IS 456 column requirements (40 mm). This non-compliance was observed particularly in fire-affected zones.

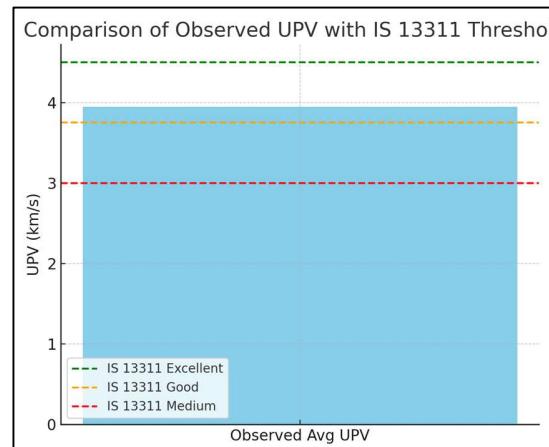
Fig. 4.5 Comparison of Observed UPV with IS 13311 Thresholds

As shown in Fig. 4.5, observed UPV values exceeded the “Good” threshold of IS 13311 in most structural elements, confirming adequate internal homogeneity. However, members in fire-exposed zones fell closer to the “Medium” classification, indicating localized deterioration.

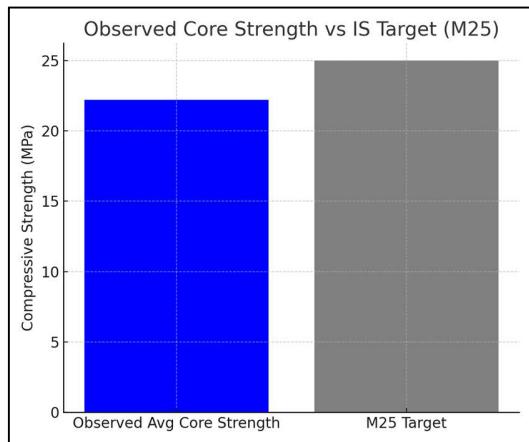
Fig. 4.6 Observed Core Strength vs IS Target (M25)

Fig. 4.6 illustrates that average core strengths (20–25 MPa) were slightly below the IS M25 target of 25 MPa, indicating a strength reduction of 10–20%. While still serviceable, this highlights the necessity of retrofitting in fire-affected members.

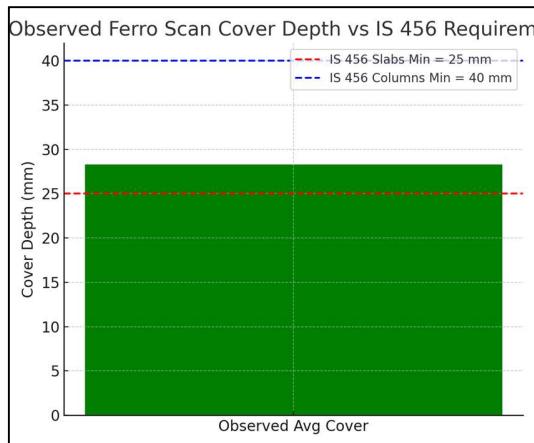
Fig. 4.7 Observed Ferro Scan Cover Depth vs IS 456 Requirements

As depicted in Fig. 4.7, observed average cover (≈ 30 mm) met slab requirements but fell short of IS 456 minimum covers for columns (40 mm). This non-compliance poses a durability risk, especially under fire and seismic loading.

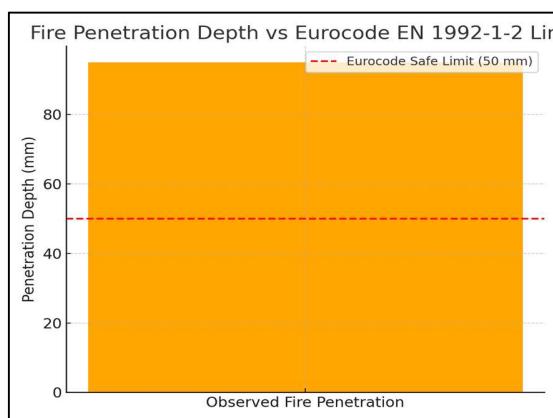
Fig. 4.8 Fire Penetration Depth vs Eurocode EN 1992-1-2 Limit

Fig. 4.8 shows fire penetration depths (75–100 mm) exceeding Eurocode EN 1992-1-2 safe limits (50 mm). This supports the decision for slab dismantling in highly affected grids, as residual capacity was compromised beyond code-acceptable limits.
