Post-Fire Structural Health Assessment of Reinforced Concrete Structures

Amandeep ¹, Monu Kumar ², Harish Chawla ³ Department of Civil Engineering
BRCM College of Engineering & Technology, Bahal, India

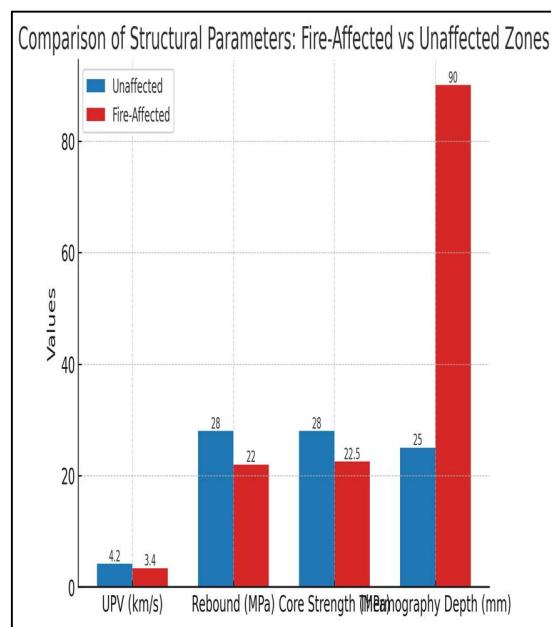
Table 6.A Fire Affected vs Unaffected Zones

UPV results confirmed that more than 70% of the members were classified as “Good to Excellent” per IS 13311, with localized deterioration in fire-exposed slabs and columns. Rebound hammer values averaged 22 MPa, while core strengths ranged from 20–25 MPa, slightly below the design M25 grade. Ferro scanning revealed reinforcement continuity but reduced cover in columns, and thermography confirmed fire penetration depths exceeding Eurocode limits, justifying slab reconstruction.

Targeted retrofitting measures were recommended, including slab replacement, four-sided jacketing of severely damaged columns, two-sided jacketing of moderately affected columns, and beam guniting. The integrated NDT–core approach proved effective for accurate, minimally invasive evaluation, reinforcing the need.
